**Flood Control Project Maintenance
Levee Inspections**

Fall 2018 Levee Maintenance Deficiency Summary Report

Sacramento Maintenance Yard Maintenance Area 0004

Waterway	Bank	Unit Miles	Inspection Start/End	Inspector
Unit No. 01 Sacramento River	Right	3.47	10/25/2018 10/25/2018	Luz Dial

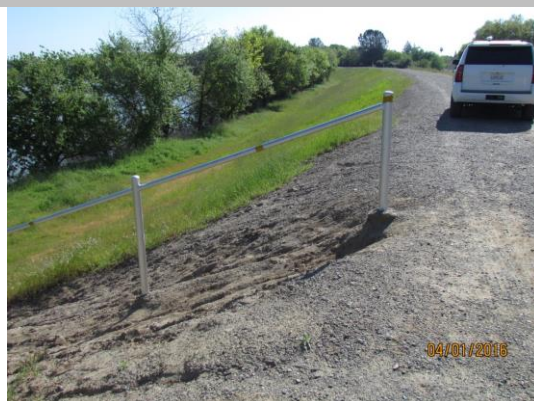
Photo 1 of 1 : FA_2018_MA0004_298_16_20180919_00009.jpg

LM Start	0.00	Rating **	M	Issue No.	16
LM End	0.00	Issue Type +	Ma	Location *	WS
Category	Earthen Levee			GPS Latitude/Longitude	
				Start	End
Item	Slope Stability			38.596823 °	38.596823 °
				-121.547608 °	-121.547608 °
DWR ID	DWR_MA0004_01_s_2016_16				
Comment Code					
S2 : Repair the levee slope damaged by foot traffic and prevent access where possible.					
Inspector Comment

View of the slope stability on the waterward side of the levee looking downstream. Spring 2016.

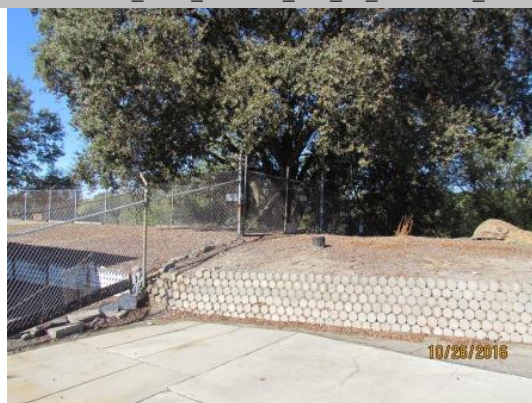
Photo 1 of 1 : FA_2018_MA0004_298_15_20180919_00008.jpg

LM Start	0.41	Rating **	U	Issue No.	15
LM End	0.41	Issue Type +	En	Location *	CR
Category	Earthen Levee			GPS Latitude/Longitude	
				Start	End
Item	Encroachments			38.598661 °	38.598661 °
				-121.540895 °	-121.540895 °
DWR ID	DWR_MA0004_01_f_2016_15				
Comment Code					
BU : Building					
Inspector Comment					
Chain link fence crosses the levee. USACE facility.

View of fence crossing the crown on NE side of USACE facility. Fall 2016.

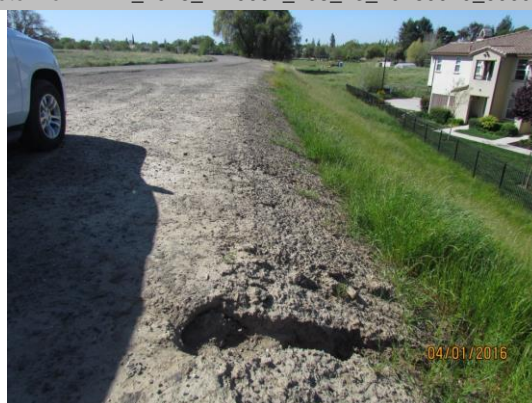
Photo 2 of 2 : FA_2018_MA0004_298_13_20180919_00006.jpg

Perspective view of the runoff erosion on the landward side of the levee looking upstream. Spring 2016.

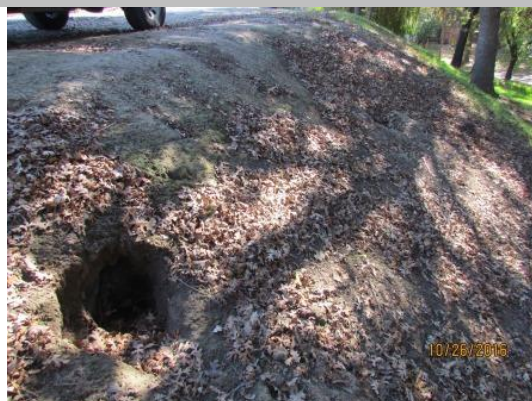
Photo 1 of 1 : FA_2018_MA0004_298_20_20180919_00012.jpg

LM Start	2.63	Rating **	M	Issue No.	20
LM End	2.63	Issue Type +	Ma	Location *	LS
Category	Earthen Levee			GPS Latitude/Longitude	
				Start	End
Item	Animal Control			38.591532°	38.591532°
				-121.511646°	-121.511646°
DWR ID	DWR_MA0004_01_f_2016_20				
Comment Code					
A3 : No rodents visible, but rodent burrows visible; need to backfill and compact or grout burrows.					
Inspector Comment					
The rodents have been exterminated, but the hole needs to be backfilled.

Large diameter animal burrows on LS slope. Fall 2016.

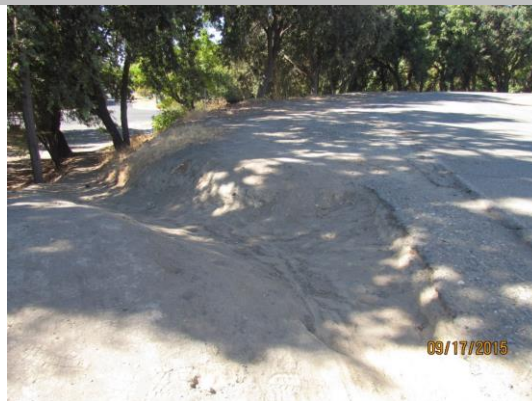
Photo 1 of 1 : FA_2018_MA0004_298_22_20180919_00014.jpg

LM Start	2.65	Rating **	A/W	Issue No.	22
LM End	2.65	Issue Type +	Ma	Location *	LS
Category	Earthen Levee			GPS Latitude/Longitude	
				Start	End
Item	Slope Stability			38.591380 °	38.591380 °
				-121.511345 °	-121.511345 °
DWR ID	DWR_MA0004_01_f_2015_22				
Comment Code					
S2 : Repair the levee slope damaged by foot traffic and prevent access where possible.					
Inspector Comment					
Material has been added to build the slope back up, however the path is still active. Recommend monitoring.

View looking upstream of the depression on the landward side of the levee due to foot traffic. Fall 2015.

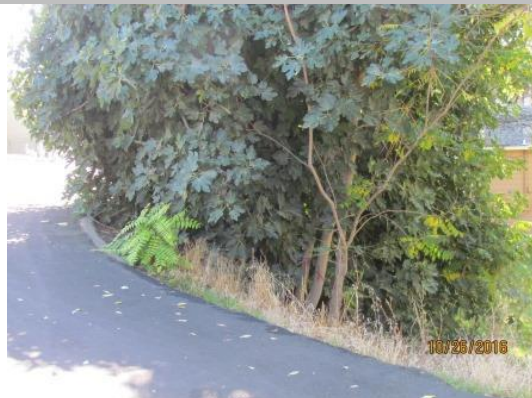
Photo 1 of 1 : FA_2018_MA0004_298_21_20180919_00013.jpg

LM Start	2.67	Rating **	M	Issue No.	21
LM End	2.68	Issue Type +	En	Location *	LS
Category	Earthen Levee			GPS Latitude/Longitude	
				Start	End
Item	Vegetation			38.591228 °	38.591080 °
				-121.511130 °	-121.510994 °
DWR ID	DWR_MA0004_01_f_2016_21				
Comment Code					
V6 : Landscaping					
Inspector Comment

View of small trees that block visibility of LS slope. Fall 2016.

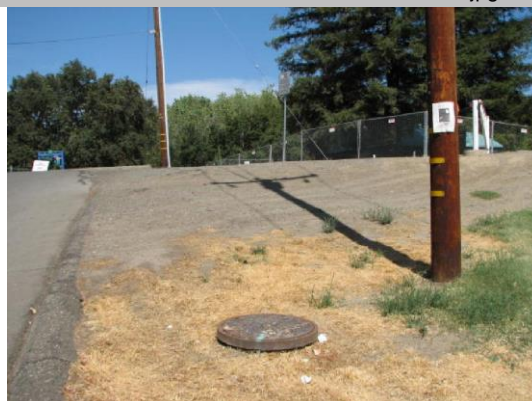
Photo 1 of 2 : UCIP_FA_2018_41443_9371.jpg

LM Start	2.69	Rating **	M	Issue No.	30
LM End	2.69	Issue Type +	En	Location *	
Category	Supplemental			GPS Latitude/Longitude	
				Start	End
Item	DWR UCIP Field Study			38.590910 °	38.590910 °
				-121.510830 °	-121.510830 °
DWR ID	19405				
Comment Code					
Inspector Comment					
FS_ID:41443 DS_ID:19405 EP_NO: N/A Repair Type: Non-Urgent Crossing Status: Found UCIP Comments: Found during the field survey, not listed in the desk study. FIELD_STRUCT_DESC: 6-inch steel sewer line from the public facility of the boat launching area. No other details available. FS Date: 9/12/2012

Landside view- manhole on the side of the levee and a road.

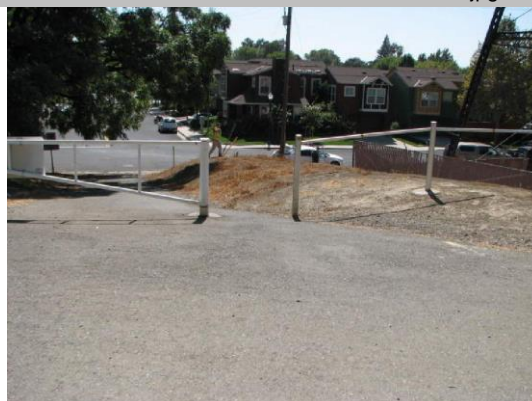
Photo 1 of 3 : UCIP_FA_2018_41485_9367.jpg

LM Start	2.77	Rating **	M	Issue No.	31
LM End	2.77	Issue Type +	En	Location *	
Category	Supplemental			GPS Latitude/Longitude	
				Start	End
Item	DWR UCIP Field Study			38.590140 °	38.590140 °
				-121.509750 °	-121.509750 °
DWR ID	19406				
Comment Code					
Inspector Comment					
FS_ID:41485 DS_ID:19406 EP_NO: N/A Repair Type: Non-Urgent Crossing Status: Found UCIP Comments: Found during field survey. Not listed in the desk study. FIELD_STRUCT_DESC: 1 of 2: 3-inch wrapped galvanized iron (GI) water pipe through the levee, at an unknown depth. Pipe daylights in a metal cage box. Valve box for the pipe is also found. FS Date: 9/12/2012

Landside overview

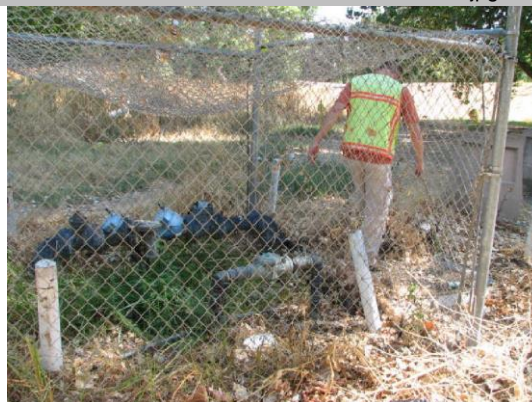
Photo 2 of 3 : UCIP_FA_2018_41485_9366.jpg

Waterside view- pipe daylight in a metal cage.

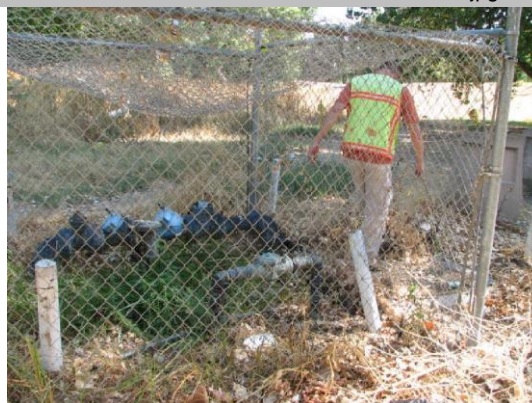
Photo 1 of 2 : UCIP_FA_2018_41486_9369.jpg

LM Start	2.82	Rating **	M	Issue No.	32
LM End	2.82	Issue Type +	En	Location *	
Category	Supplemental			GPS Latitude/Longitude	
				Start	End
Item	DWR UCIP Field Study			38.590130 °	38.590130 °
				-121.508740 °	-121.508740 °
DWR ID	19407				
Comment Code					
Inspector Comment					
FS_ID:41486 DS_ID:19407 EP_NO: N/A Repair Type: Non-Urgent Crossing Status: Found UCIP Comments: Found during field survey, not listed in the desk study. FIELD_STRUCT_DESC: 2 of 2: 5-inch wrapped galvanized iron (GI) water pipe through the levee, at an unknown depth. Pipe daylights in a metal cage box. Valve box for the pipe is also found. FS Date: 9/12/2012

Waterside view- pipe daylight in a cage.

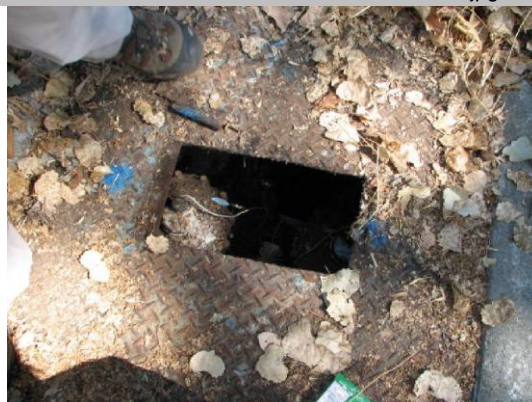
Photo 2 of 2 : UCIP_FA_2018_41486_9368.jpg

Waterside view- manhole/control valve.

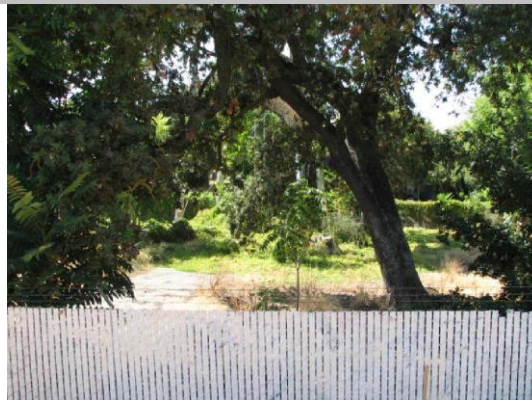
Photo 1 of 3 : UCIP_FA_2018_41557_9767.jpg

LM Start	2.93	Rating **	M	Issue No.	33	
LM End	2.93	Issue Type +	En	Location *		
Category	Supplemental			GPS Latitude/Longitude		
				Start	End	
Item	DWR UCIP Field Study			38.588688 °	38.588688 °	
				-121.507910 °	-121.507910 °	
DWR ID	18883					
Comment Code						
Inspector Comment						
FS_ID:41557 DS_ID:18883 EP_NO: N/A Repair Type: Non-Urgent Crossing Status: Found UCIP Comments: Abandoned 7-inch pipe found. Needs to be abandoned properly. FIELD_STRUCT_DESC: *ABANDONED* 2 of 4: 7-inch pipe of an unknown material or purpose through the levee, 18.6 feet below the crown. Unable to locate. Pipe exposed and extends 10 feet from the bank and 5 feet above current water surface. Needs to be removed or grouted. [Additional Reference(s): DWR Levee Log, 2005. USACE Sacramento O&M Manual 116, August 1955, (RM 59.65)]. FS Date: 9/12/2012

Land side view- Water tower area.

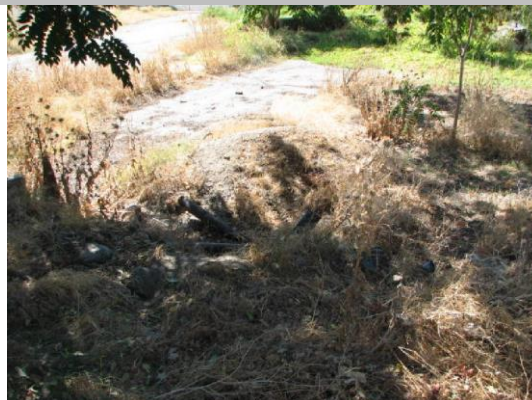
Photo 2 of 3 : UCIP_FA_2018_41557_9770.jpg

Land side view- abandoned pipes inside the tower area

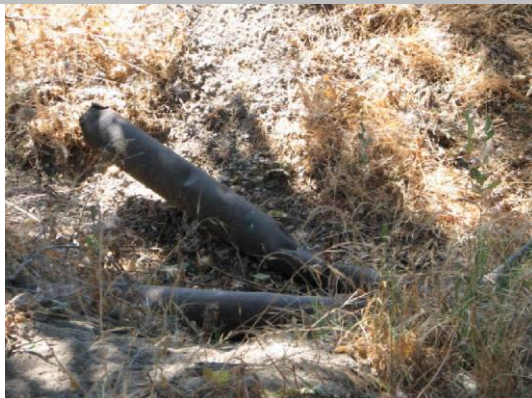
Photo 3 of 3 : UCIP_FA_2018_41557_9769.jpg

Land side view- abandoned pipes inside the tower area.

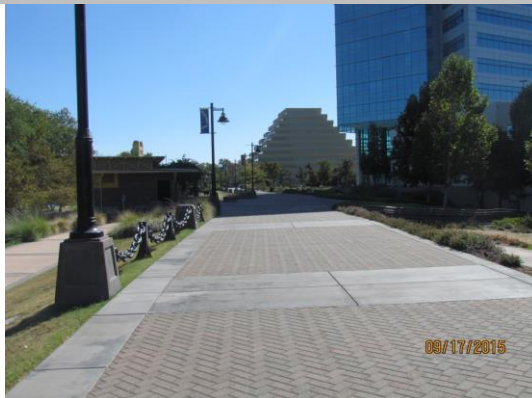
Photo 1 of 2 : FA_2018_MA0004_298_12_20180919_00003.jpg

LM Start	3.08	Rating **	A/W	Issue No.	12
LM End	3.45	Issue Type +	En	Location *	WS
Category	Earthen Levee			GPS Latitude/Longitude	
				Start	End
Item	Vegetation			38.586434 °	38.581349 °
				-121.508090 °	-121.509547 °
DWR ID	DWR_MA0004_01_s_2012_12				
Comment Code					
V6 : Landscaping					
Inspector Comment					
West Sacramento's River walk runs from Tower Bridge to the I Street bridge.

The Riverwalk is part of the landscape on the levee. Fall 2015.

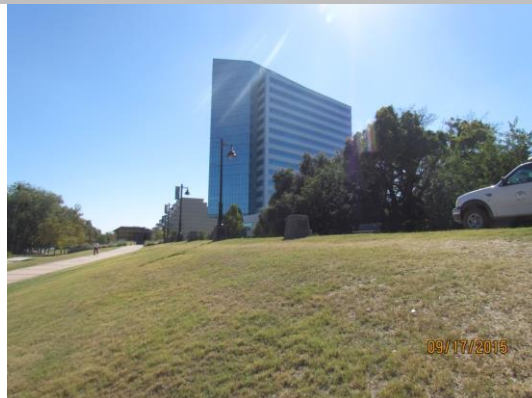
Photo 2 of 2 : FA_2018_MA0004_298_12_20180919_00004.jpg

Landscaping and buildings are on the crown and waterward side of the levee. Fall 2015.

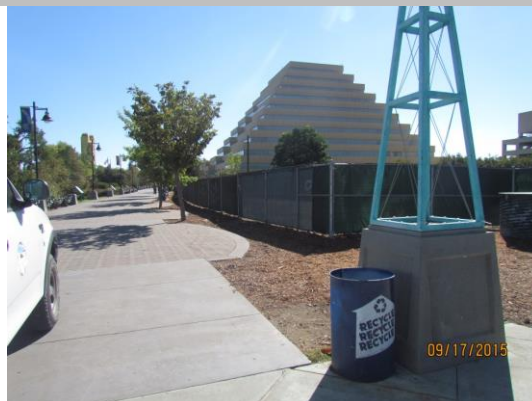
Photo 1 of 2 : FA_2018_MA0004_298_27_20180919_00017.jpg

LM Start	3.24	Rating **	M	Issue No.	27
LM End	3.29	Issue Type +	En	Location *	LS
Category	Earthen Levee			GPS Latitude/Longitude	
				Start	End
Item	Encroachments			38.584168 °	38.583435 °
				-121.508632 °	-121.508785 °
DWR ID	DWR_MA0004_01_f_2015_27				
Comment Code					
FE : Fence					
Inspector Comment					
There is a fence at the levee shoulder.

View looking downstream of the fence on the crown of the levee . Fall 2015.

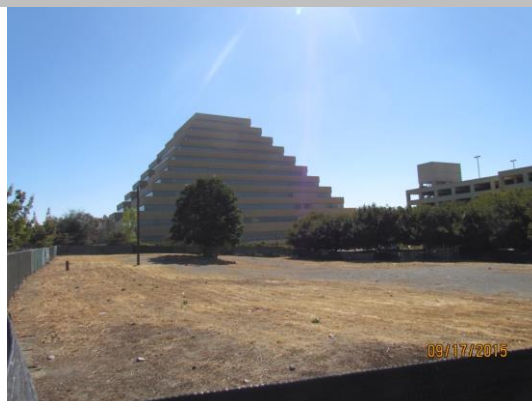
Photo 2 of 2 : FA_2018_MA0004_298_27_20180919_00018.jpg

View looking downstream of the inside of the fence . Fall 2015.
